**Flood Control Project Maintenance
Levee Inspections**

Maintenance Issue Types Only, Levee Inspection Report By Mile - Fall 2014

Reclamation District No. 1001 Nicolaus

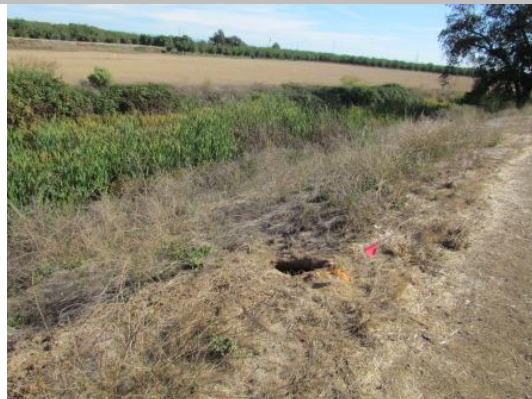
Photo 1 of 2 : FA_2014_RD1001_35_4_20141103_00010.jpg

LM Start	0.31	Rating **	M	Issue No.	4
LM End	0.31	Issue Type +	Ma	Location *	WS
Category	Earthen Levee			GPS Latitude/Longitude	
				Start	End
Item	Animal Control			38.974331 °	38.974331 °
				-121.476481 °	-121.476481 °
DWR ID	DWR_RD1001_02_f_2014_4				
Action/Comments					
No rodents visible, but rodent burrows visible; need to backfill and compact or grout burrows. Inspector Comments: Animal hole on waterward levee slope near the crown. Hole is approximately 1'dia and 8" deep.

This photo was taken from the levee crown facing east looking down the waterward slope at an animal burrow. Fall 2014.

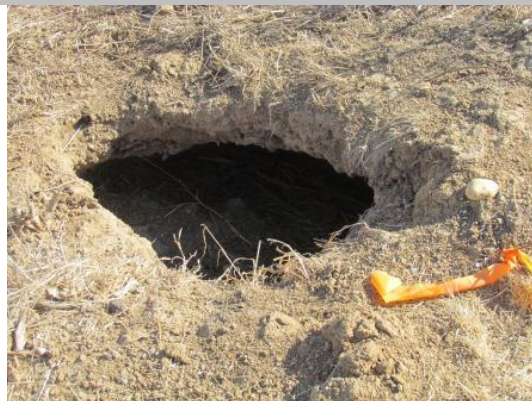
Photo 2 of 2 : FA_2014_RD1001_35_4_20141103_00011.jpg

Another picture of the animal burrow. Fall 2014.

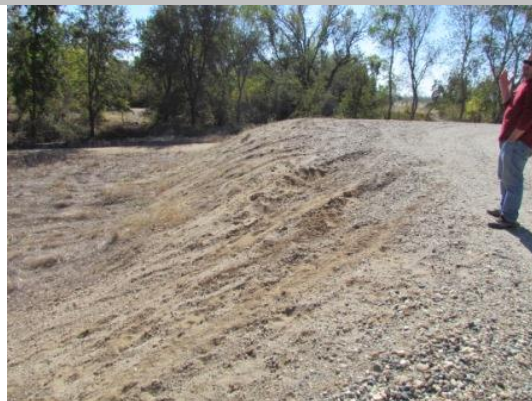
Photo 1 of 1 : FA_2014_RD1001_37_2_20141020_00002.jpg

LM Start	0.11	Rating **	M	Issue No.	2
LM End	0.11	Issue Type +	Ma	Location *	CR
Category	Earthen Levee			GPS Latitude/Longitude	
				Start	End
Item	Slope Stability			39.006569 °	39.006569 °
				-121.377037 °	-121.377037 °
DWR ID	DWR_RD1001_03_f_2013_2				
Action/Comments					
Repair the levee slope damaged by vehicle traffic and prevent access where possible.					
Inspector Comments: Rutting caused by vehicles driving up the landward levee slope.

This photo was taken from the crown of the levee facing west looking down the slope at rutting caused by vehicles driving up the landward levee slope.

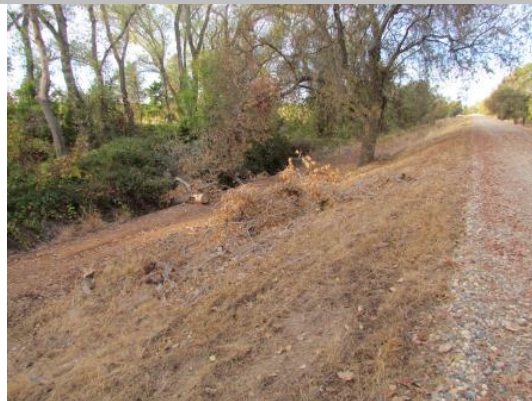
Photo 1 of 1 : FA_2014_RD1001_37_18_20141103_00040.jpg

LM Start	0.31	Rating **	M	Issue No.	18
LM End	0.31	Issue Type +	Ma	Location *	LS
Category	Earthen Levee			GPS Latitude/Longitude	
				Start	End
Item	Encroachments			39.006336 °	39.006336 °
				-121.380524 °	-121.380524 °
DWR ID	DWR_RD1001_03_f_2014_18				
Action/Comments					
Tree or limb

This photo was taken from the levee crown facing west looking down the landward slope at a fallen tree that needs to be removed. Fall 2014.

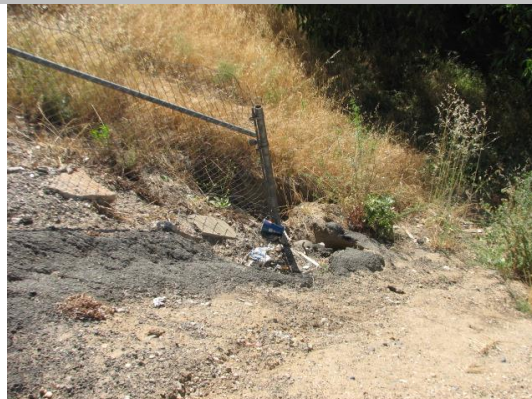
Photo 1 of 1 : FA_2014_RD1001_37_38_20141020_00030.jpg

LM Start	6.50	Rating **	M	Issue No.	38
LM End	6.50	Issue Type +	Ma	Location *	LS
Category	Earthen Levee			GPS Latitude/Longitude	
				Start	End
Item	Erosion / Bank Caving			38.984010 °	38.984010 °
				-121.487420 °	-121.487420 °
DWR ID	DWR_RD1001_03_s_2013_38				
Action/Comments					
Schedule repair of erosion site prior to the next inspection.

Erosion caused by run off from the roadway. Spring 2013

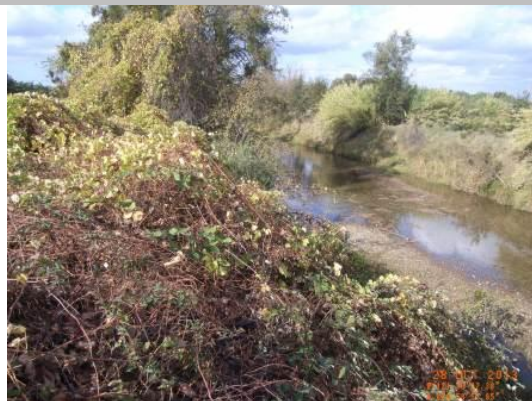
Photo 1 of 1 : FA_2014_RD1001_37_19_20141020_00012.jpg

LM Start	7.25	Rating **	M	Issue No.	19
LM End	7.35	Issue Type +	Ma	Location *	WS
Category	Supplemental			GPS Latitude/Longitude	
				Start	End
Item	USACE Erosion Survey			38.982737 °	38.982572 °
				-121.501144 °	-121.502797 °
DWR ID	DWR_RD1001_03_f_2014_19				
Action/Comments					
Inspector Comments: 2008 - Sandy/silty banks with rotational slab failures creating near vertical bank with pop-outs due to tree failures. Narrow berm. 2013: No observed changes. [2013 Site ID: BER_5-7_L]

USACE 2013 Photo #1

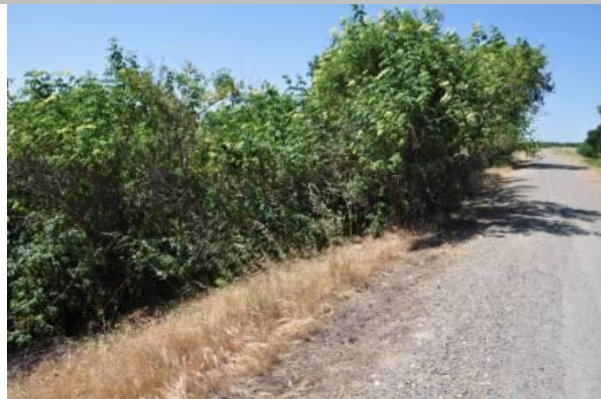
Photo 1 of 1 : FA_2014_RD1001_37_22_20141020_00013.jpg

LM Start	11.29	Rating **	M	Issue No.	22
LM End	11.32	Issue Type +	Ma	Location *	LS
Category	Earthen Levee			GPS Latitude/Longitude	
				Start	End
Item	Vegetation			38.953367 °	38.953025 °
				-121.551428 °	-121.551808 °
DWR ID	DWR_RD1001_03_s_2012_22				
Action/Comments					
Elderberries are blocking visibility and flood fight capability.

RD 1001 Unit 3 - L/S slope -Elderberries

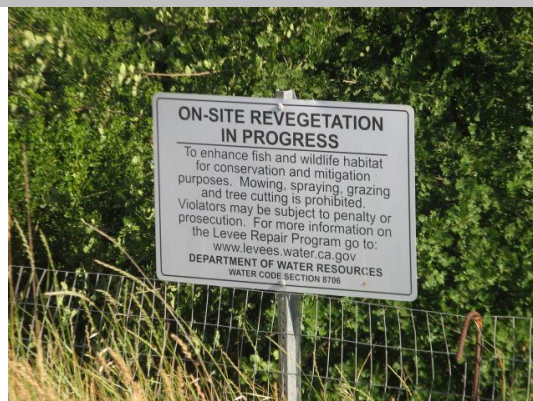
Photo 1 of 1 : FA_2014_RD1001_37_25_20141020_00015.jpg

LM Start	11.65	Rating **	A/W	Issue No.	25
LM End	11.86	Issue Type +	Ma	Location *	WS
Category	Earthen Levee			GPS Latitude/Longitude	
				Start	End
Item	Vegetation			38.951302 °	38.950960 °
				-121.556872 °	-121.560717 °
DWR ID	DWR_RD1001_03_s_2013_25				
Action/Comments					
Environmental Requirements.

Revegetation site in progress. Spring 2013

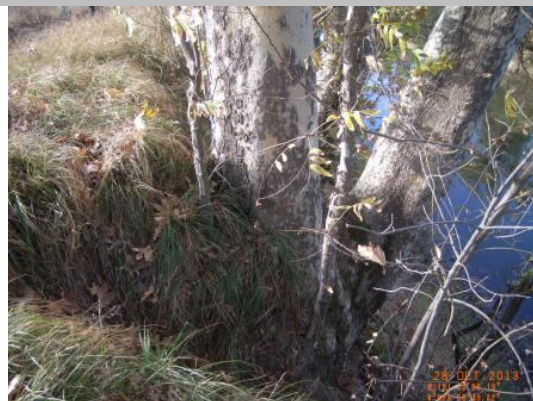
Photo 1 of 1 : FA_2014_RD1001_37_1_20141020_00001.jpg

LM Start	12.13	Rating **	M	Issue No.	1
LM End	12.22	Issue Type +	Ma	Location *	WS
Category	Supplemental			GPS Latitude/Longitude	
				Start	End
Item	USACE Erosion Survey			38.947591 °	38.946477 °
				-121.563390 °	-121.564094 °
DWR ID	DWR_RD1001_03_f_2014_1				
Action/Comments					
Inspector Comments: 2006 - Multiple rotational failures in the berm. Erosion is into the levee toe and lower slope. Tension cracks extensive at top of bank. Cohesive toe creates a bench on which failures occur. 2007 - Still steep bank with some berm with pistol-butted reeds. 2012 - Site extended upstream due to additional slumping. Slopes slightly steeper. 2013: No observed changes. [2013 Site ID: BER_0-8_L]

USACE 2013 Photo #1

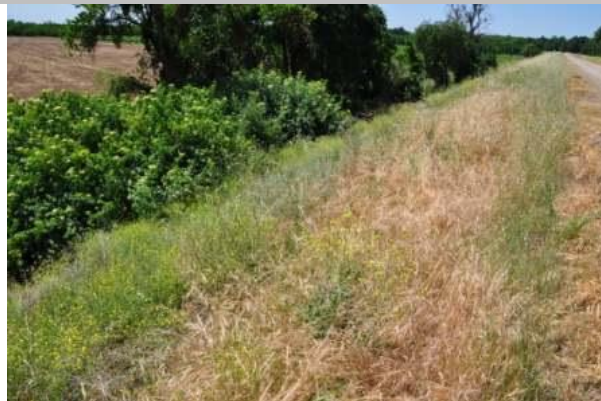
Photo 1 of 1 : FA_2014_RD1001_37_27_20141020_00017.jpg

LM Start	12.24	Rating **	M	Issue No.	27
LM End	12.24	Issue Type +	Ma	Location *	LS
Category	Earthen Levee			GPS Latitude/Longitude	
				Start	End
Item	Vegetation			38.946248 °	38.946248 °
				-121.564220 °	-121.564220 °
DWR ID	DWR_RD1001_03_s_2012_27				
Action/Comments					
Elderberries are blocking visibility and flood fight capability.

RD 1001 Unit 3 - L/S slope -Elderberries @ toe.

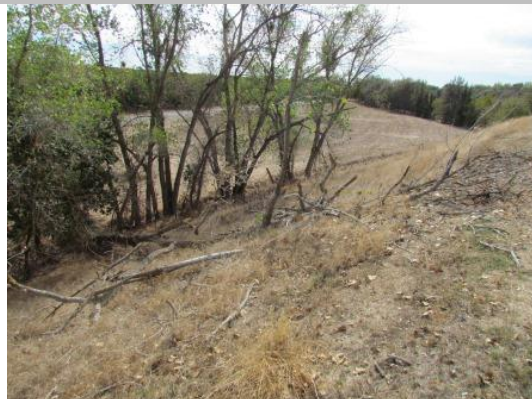
Photo 1 of 1 : FA_2014_RD1001_38_16_20141103_00034.jpg

LM Start	1.75	Rating **	M	Issue No.	16
LM End	1.75	Issue Type +	Ma	Location *	LS
Category	Earthen Levee			GPS Latitude/Longitude	
				Start	End
Item	Encroachments			38.916965 °	38.916965 °
				-121.570147 °	-121.570147 °
DWR ID	DWR_RD1001_04_f_2014_16				
Action/Comments					
Tree or limb

This photo was taken from the levee crown facing west looking down the landward slope at a tree that needs to be removed. Fall 2014.

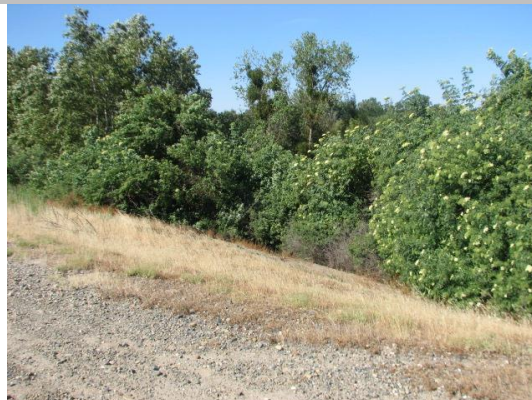
Photo 1 of 1 : FA_2014_RD1001_38_27_20141020_00022.jpg

LM Start	5.05	Rating **	A/W	Issue No.	27
LM End	5.05	Issue Type +	Ma	Location *	WS
Category	Earthen Levee			GPS Latitude/Longitude	
				Start	End
Item	Vegetation			38.884813 °	38.884813 °
				-121.611493 °	-121.611493 °
DWR ID	DWR_RD1001_04_s_2013_27				
Action/Comments					
Elderberries are blocking visibility and flood fight capability.

Elderberry Spring 2013

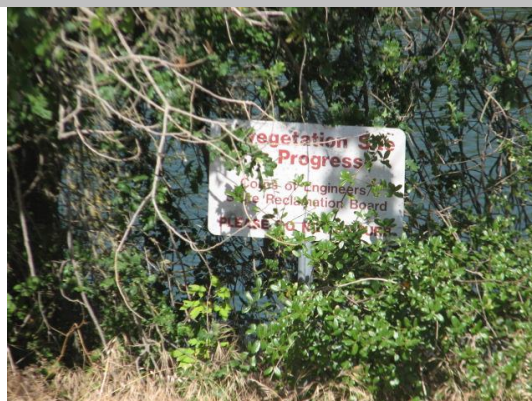
Photo 1 of 1 : FA_2014_RD1001_38_28_20141020_00023.jpg

LM Start	6.86	Rating **	A/W	Issue No.	28
LM End	6.86	Issue Type +	Ma	Location *	WS
Category	Earthen Levee			GPS Latitude/Longitude	
				Start	End
Item	Vegetation			38.861071 °	38.861071 °
				-121.623332 °	-121.623332 °
DWR ID	DWR_RD1001_04_s_2013_28				
Action/Comments					
Environmental Requirements.

Revegetation site. Spring 2013

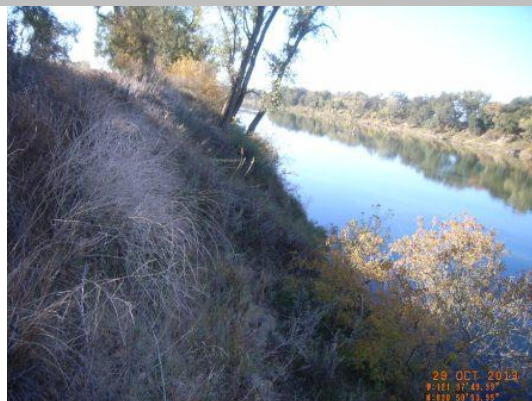
Photo 1 of 1 : FA_2014_RD1001_38_5_20141020_00005.jpg

LM Start	7.54	Rating **	M	Issue No.	5
LM End	7.86	Issue Type +	Ma	Location *	WS
Category	Supplemental			GPS Latitude/Longitude	
				Start	End
Item	USACE Erosion Survey			38.852394 °	38.848004 °
				-121.629231 °	-121.630873 °
DWR ID	DWR_RD1001_04_f_2014_5				
Action/Comments					
Inspector Comments: 2000 - Steep bank off berm with some slumps and fallen trees, continued erosion. 2002 - Site lengthened upstream and downstream due to vertical bank along most of the reach. 2010 - Site extended upstream. 2011 - Minimal new erosion. 2012 - Site extended on the upstream end, new tree pop-out, and bank erosion continues to worsen. 2013: Minor new erosion at the toe and top of bank. [2013 Site ID: FHR_5-0_L]

USACE 2013 Photo #1

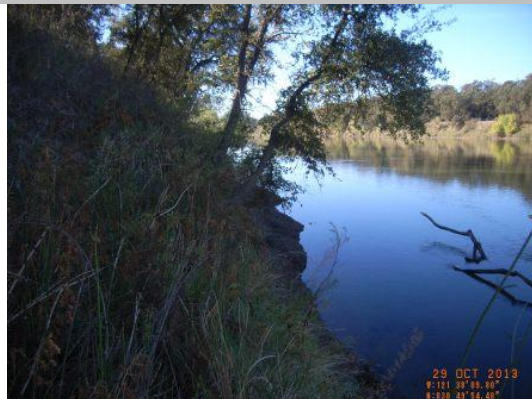
Photo 1 of 1 : FA_2014_RD1001_38_4_20141020_00004.jpg

LM Start	8.64	Rating **	M	Issue No.	4
LM End	8.95	Issue Type +	Ma	Location *	WS
Category	Supplemental			GPS Latitude/Longitude	
				Start	End
Item	USACE Erosion Survey			38.836966 °	38.831498 °
				-121.634128 °	-121.636371 °
DWR ID	DWR_RD1001_04_f_2014_4				
Action/Comments					
Inspector Comments: 2006 - Sandy, silty bank with intermittent pockets of erosion. Rotational failure and tree pop outs are most of the problem. Some upper slope fluvial erosion. 2010 - Site extended upstream. The lower Feather may benefit from a regional repair. 2011 - Site combined with 3.6. Minimal new erosion. 2013: New erosion observed at bank toe. Trees on site now have exposed roots. [2013 Site ID: FHR 3-8 L]

USACE 2013 Photo #1

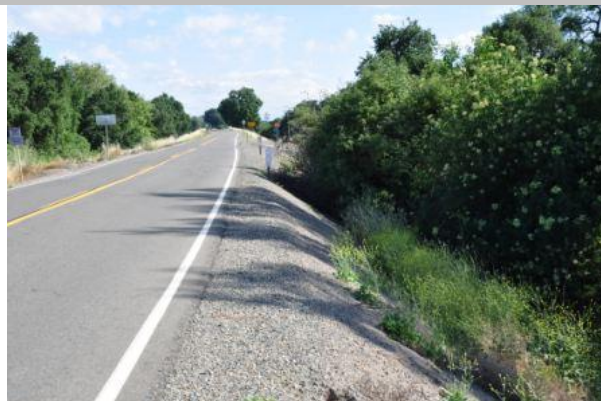
Photo 1 of 1 : FA_2014_RD1001_38_12_20141020_00010.jpg

LM Start	8.72	Rating **	M	Issue No.	12
LM End	8.72	Issue Type +	Ma	Location *	LS
Category	Earthen Levee			GPS Latitude/Longitude	
				Start	End
Item	Vegetation			38.835766 °	38.835766 °
				-121.633966 °	-121.633966 °
DWR ID	DWR_RD1001_04_s_2012_12				
Action/Comments					
Elderberries are blocking visibility and flood fight capability.

RD 1001 Unit 4 - W/S slope - Elderberries

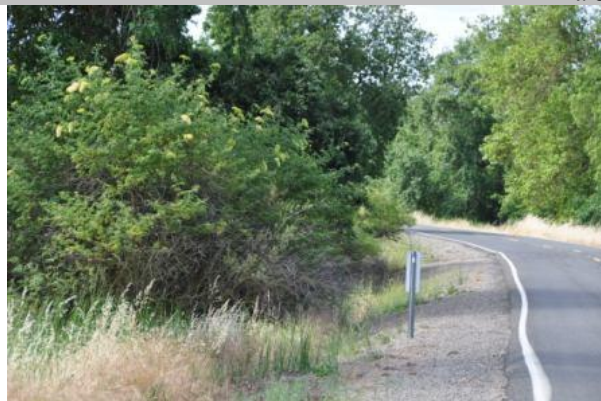
Photo 1 of 1 : FA_2014_RD1001_38_22_20141020_00016.jpg

LM Start	11.15	Rating **	M	Issue No.	22
LM End	11.15	Issue Type +	Ma	Location *	LS
Category	Earthen Levee			GPS Latitude/Longitude	
				Start	End
Item	Vegetation			38.802508 °	38.802508 °
				-121.632862 °	-121.632862 °
DWR ID	DWR_RD1001_04_s_2012_22				
Action/Comments					
Elderberries are blocking visibility and flood fight capability.

RD 1001 Unit 4 - L/S slope - Elderberries

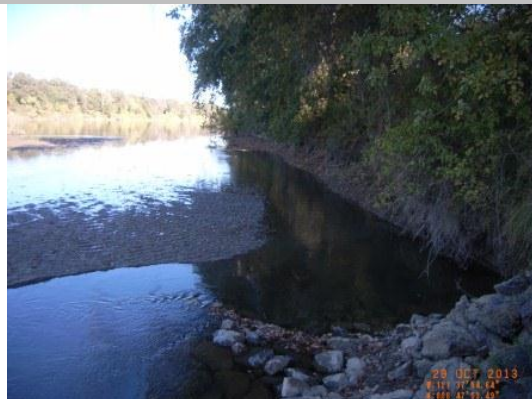
Photo 1 of 1 : FA_2014_RD1001_38_2_20141020_00002.jpg

LM Start	11.19	Rating **	M	Issue No.	2
LM End	11.44	Issue Type +	Ma	Location *	WS
Category	Supplemental		GPS Latitude/Longitude		
			Start	End	
Item	USACE Erosion Survey		38.800920 °	38.798165 °	
			-121.633050 °	-121.631939 °	
DWR ID	DWR_RD1001_04_f_2014_2

Inspector Comments: 2000 - Site is relatively stable except for some toe erosion at the upstream end, recommend monitoring the upstream end. 2004 - Some new block failures (10ft deep) at the toe of the upstream end. 2007 - Some minor new slumping at the waterline. 2013: Minor new erosion along the toe of the bank. [2013 Site ID: FHR_1-0_L]

USACE 2013 Photo #1

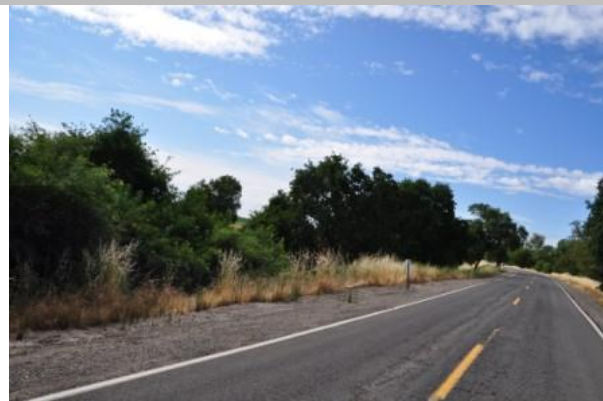
Photo 1 of 1 : FA_2014_RD1001_38_23_20141020_00017.jpg

LM Start	11.32	Rating **	M	Issue No.	23
LM End	11.32	Issue Type +	Ma	Location *	LS
Category	Earthen Levee		GPS Latitude/Longitude		
			Start	End	
Item	Vegetation		38.800112 °	38.800112 °	
			-121.632242 °	-121.632242 °	
DWR ID	DWR_RD1001_04_s_2012_23

Elderberries are blocking visibility and flood fight capability.

RD 1001 Unit 4 - L/S slope - Elderberries

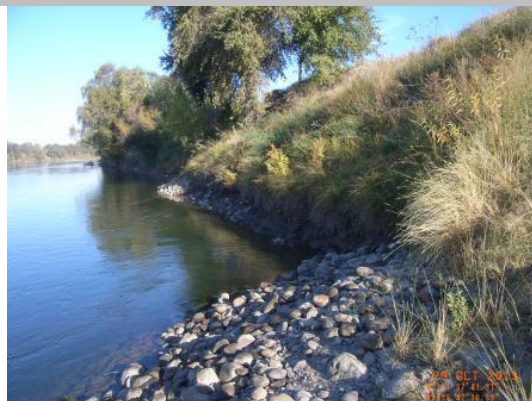
Photo 1 of 1 : FA_2014_RD1001_38_1_20141020_00001.jpg

LM Start	11.68	Rating **	M	Issue No.	1
LM End	11.85	Issue Type +	Ma	Location *	WS
Category	Supplemental		GPS Latitude/Longitude		
			Start	End	
Item	USACE Erosion Survey		38.795455 °	38.793394 °	
			-121.629903 °	-121.628156 °	
DWR ID	DWR_RD1001_04_f_2014_1

Inspector Comments: 1997- Deposits over top of cobble on the upper slope. 2000 - Old cobble site in poor shape; some toe retreat, but little change; steep bank. 2010 - Site extended upstream due to new toe erosion. 2012 - Minor new erosion at toe, new slumping, animals holes and cracks observed. 2013: No observed changes. [2013 Site ID: FHR_0-6_L]

USACE 2013 Photo #1

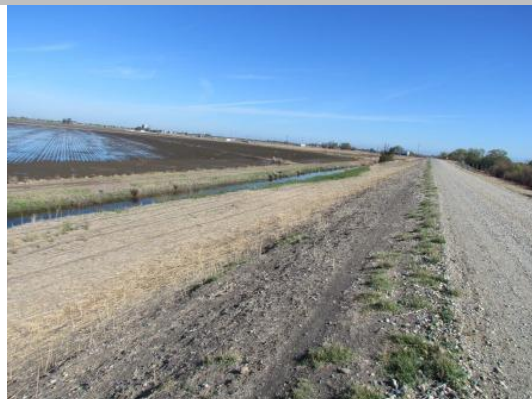
Photo 1 of 1 : FA_2014_RD1001_39_16_20141103_00018.jpg

LM Start	4.27	Rating **	A	Issue No.	16
LM End	4.27	Issue Type +	Ma	Location *	LS
Category	Earthen Levee			GPS Latitude/Longitude	
				Start	End
Item	Vegetation			38.820902 °	38.820902 °
				-121.546868 °	-121.546868 °
DWR ID	DWR_RD1001_05_f_2014_16				
Action/Comments					
Control annual grass and weeds on the levee slopes and easements.

This photo was taken from the levee crown facing east looking down the landward slope at acceptable vegetation maintenance. Fall 2014.

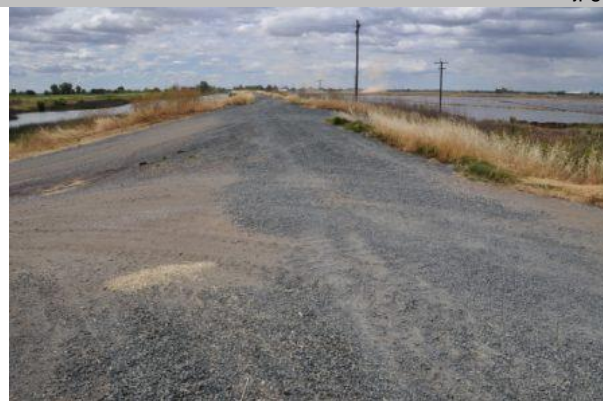
Photo 1 of 1 : FA_2014_RD1001_40_8_20141020_00005.jpg

LM Start	2.06	Rating **	M	Issue No.	8
LM End	2.06	Issue Type +	Ma	Location *	CR
Category	Earthen Levee			GPS Latitude/Longitude	
				Start	End
Item	Slope Stability			38.860002 °	38.860002 °
				-121.524873 °	-121.524873 °
DWR ID	DWR_RD1001_06_s_2012_8				
Action/Comments					
Repair the levee slope damaged by vehicle traffic and prevent access where possible.					
Inspector Comments: Subsidence due to traffic across levee crown.

RD 1001 Unit 6 - Levee Crown - Subsidence due to vehicle traffic.

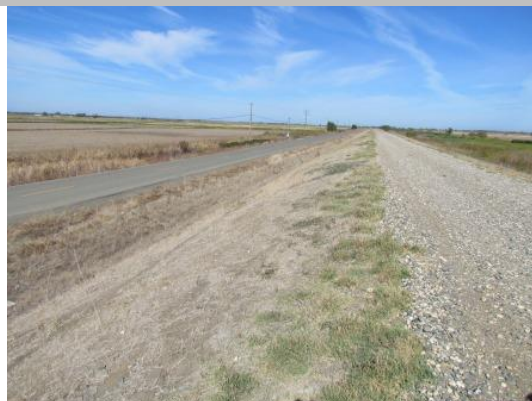
Photo 1 of 1 : FA_2014_RD1001_40_15_20141103_00015.jpg

LM Start	2.11	Rating **	A	Issue No.	15
LM End	2.11	Issue Type +	Ma	Location *	LS
Category	Earthen Levee			GPS Latitude/Longitude	
				Start	End
Item	Vegetation			38.860718 °	38.860718 °
				-121.524892 °	-121.524892 °
DWR ID	DWR_RD1001_06_f_2014_15				
Action/Comments					
Control annual grass and weeds on the levee slopes and easements.

This photo was taken from the levee crown facing north looking down the landward slope at acceptable vegetation maintenance. Fall 2014.

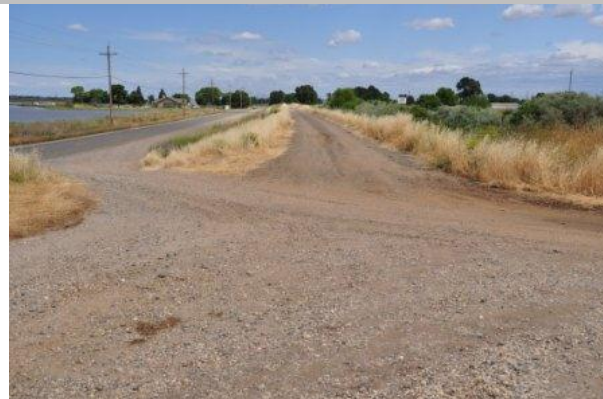
Photo 1 of 1 : FA_2014_RD1001_40_7_20141020_00004.jpg

LM Start	4.05	Rating **	M	Issue No.	7
LM End	4.05	Issue Type +	Ma	Location *	CR
Category	Earthen Levee			GPS Latitude/Longitude	
				Start	End
Item	Slope Stability			38.888821 °	38.888821 °
				-121.524733 °	-121.524733 °
DWR ID	DWR_RD1001_06_s_2012_7				
Action/Comments					
Repair the levee slope damaged by vehicle traffic and prevent access where possible.					
Inspector Comments: Levee crown subsided due to vehicle traffic across crown.

RD 1001 Unit 6 - Levee Crown - Subsidence due to vehicle traffic.

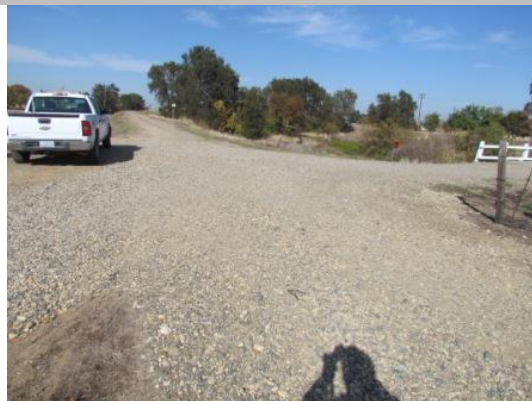
Photo 1 of 1 : FA_2014_RD1001_40_19_20141020_00006.jpg

LM Start	4.35	Rating **	M	Issue No.	19
LM End	4.35	Issue Type +	Ma	Location *	CR
Category	Earthen Levee			GPS Latitude/Longitude	
				Start	End
Item	Slope Stability			38.893114 °	38.893114 °
				-121.524715 °	-121.524715 °
DWR ID	DWR_RD1001_06_f_2013_19				
Action/Comments					
Repair the levee slope damaged by vehicle traffic and prevent access where possible.					
Inspector Comments: Levee crown subsided due to vehicle traffic across crown.

This photo was taken from the levee crown facing north looking at subsidence due to vehicle traffic across crown. Fall 2013.
